ATTACHMENT PTA-XVIII - ADJACENT PROPERTY OWNER NOTIFICATION

ATTACHMENT PTA – XVIII VIRGINIA DEPARTMENT OF ENVIRONMENTAL QUALITY ADJACENT PROPERTY OWNER NOTIFICATION

GREEN RIDGE RECYCLING AND DISPOSAL FACILITY, LLC Adjacent Property Owner Certification Statement

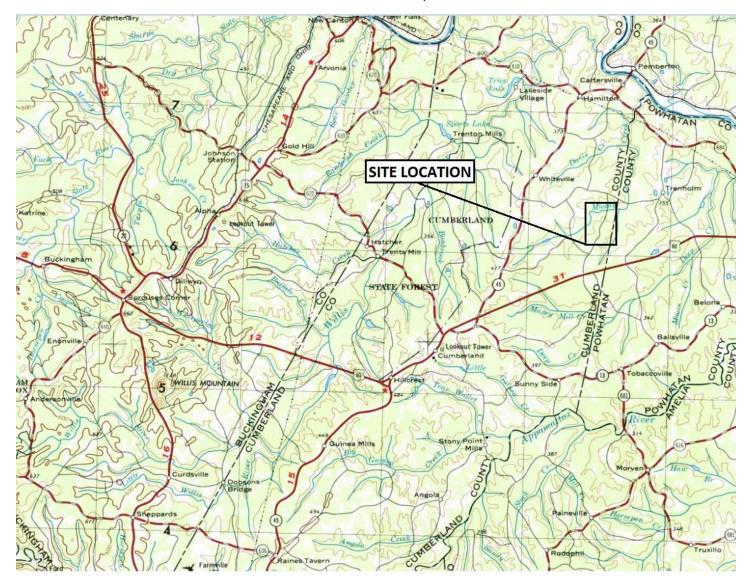
Figure 1A
Vicinity Map
Cumberland County, VA
May 2018

VICINITY MAP FOR CUMBERLAND COUNTY, VIRGINIA: SITE LOCATION

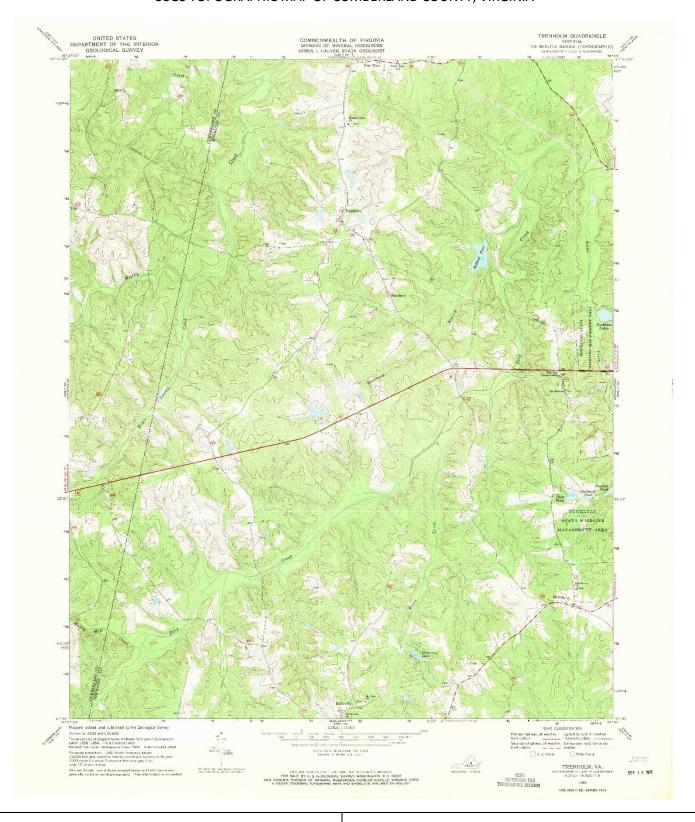
Figure 1B

U.S.G.S. Topographic Map Trenholm Quadrant, 7.5 Minute Series Cumberland County, VA May 2018

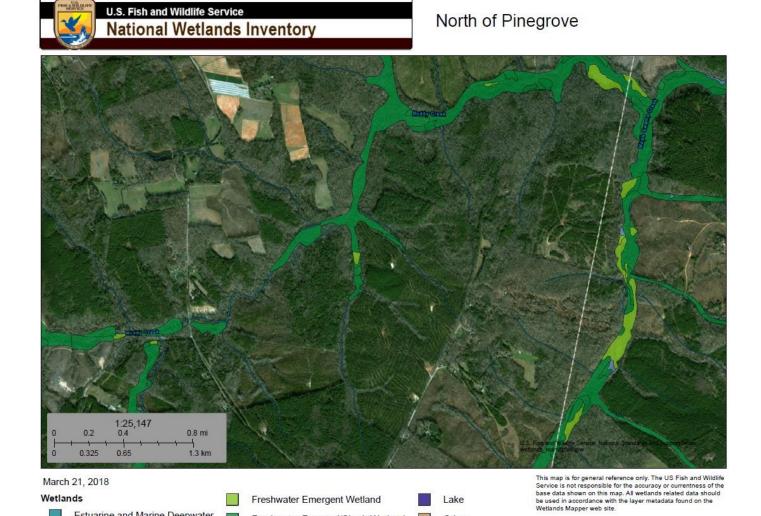
Freshwater Forested/Shrub Wetland

Freshwater Pond

National Wetlands Inventory North of Pinegrove Road Cumberland County, VA May 2018

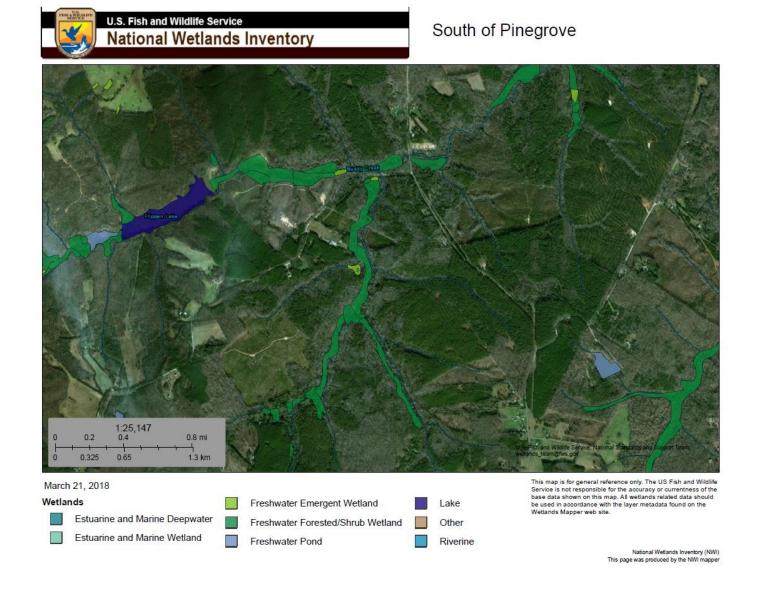
Figure 2B

National Wetlands Inventory South of Pinegrove Road Cumberland County, VA May 2018

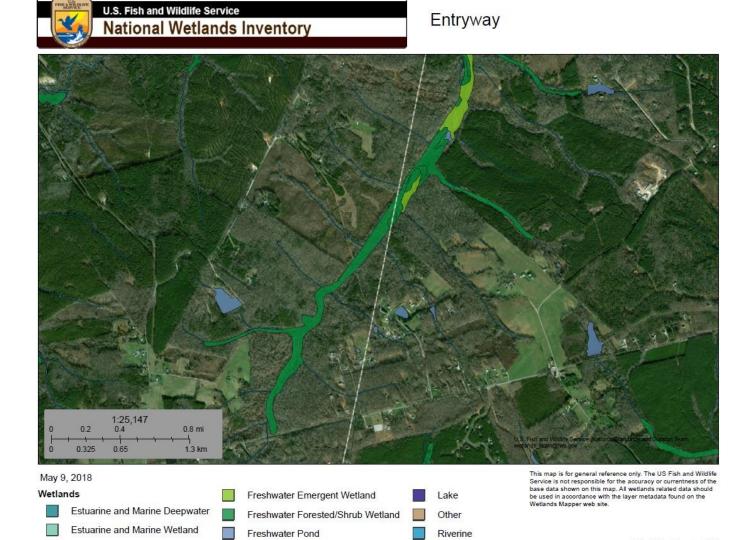
Figure 2C

National Wetlands Inventory Entryway off of Pinegrove Road Cumberland County, VA May 2018

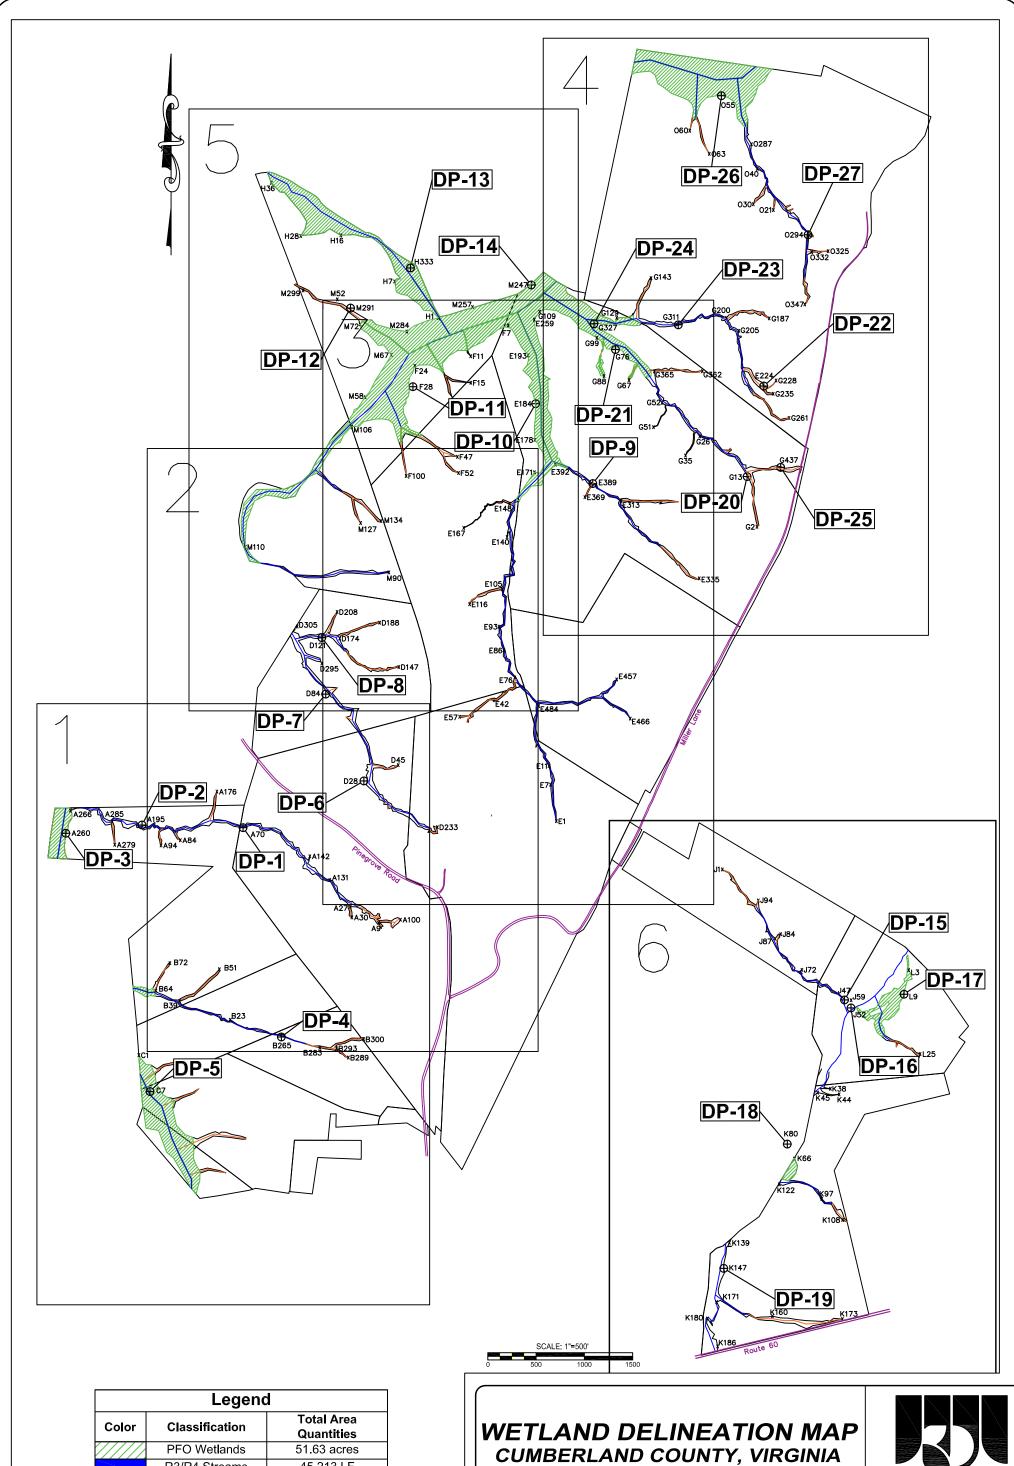
R3/R4 Streams 45,213 LF **HAMILTON DISTRICT** EPH Ephemeral 24,235 LF
